## **CSX Kanawha Trestle Inspection Report Charleston, West Virginia**

**Chris Knox, City Engineer**

**Michael Baker Jr., Inc.**

**August, 2011**

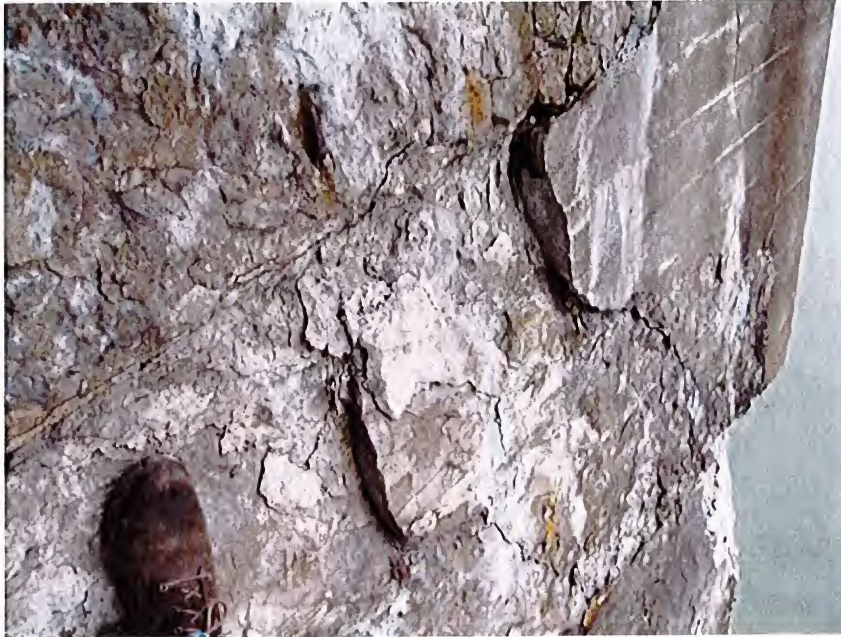
**Photo No. 1** Pier 25, north face, downstream

1. The river piers are made of poor quality concrete by today's standards and are deteriorated significantly. The strength of the core samples revealed a concrete strength of approximately 1500 to 2500 psi in the upper portion of the pier shafts. Although chloride contamination does not seem to be a problem, the concrete strength and the condition of the piers in the upper 15 to 20 ft of the shaft beneath the truss bearings is in poor condition and exhibits concrete spalls up to 1 ft deep and extensive delamination, cracks and discoloration due to deteriorating concrete (See Photos 1-4 and Appendices). In addition to the deteriorated concrete, no reinforcing steel was found in the piers. Spalls and cores up to 12" deep at random locations did not encounter any rebar. As a result, significant strengthening will be required. Wrapping the piers with carbon fiber sheets is one possible method of strengthening the piers (Items 32 to 36 in the attached estimate).

**Condition:** Extensive deterioration with spalls up to 1 ft deep

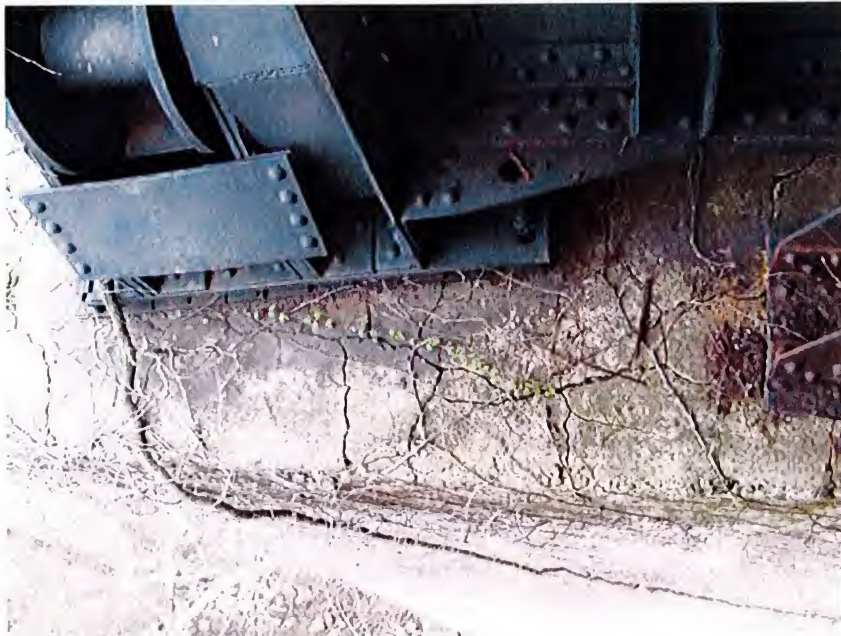
**Photo No. 2** Pier 24, top of cap, downstream truss bearing

**Condition:** Severe map cracking adjacent to the truss bearing

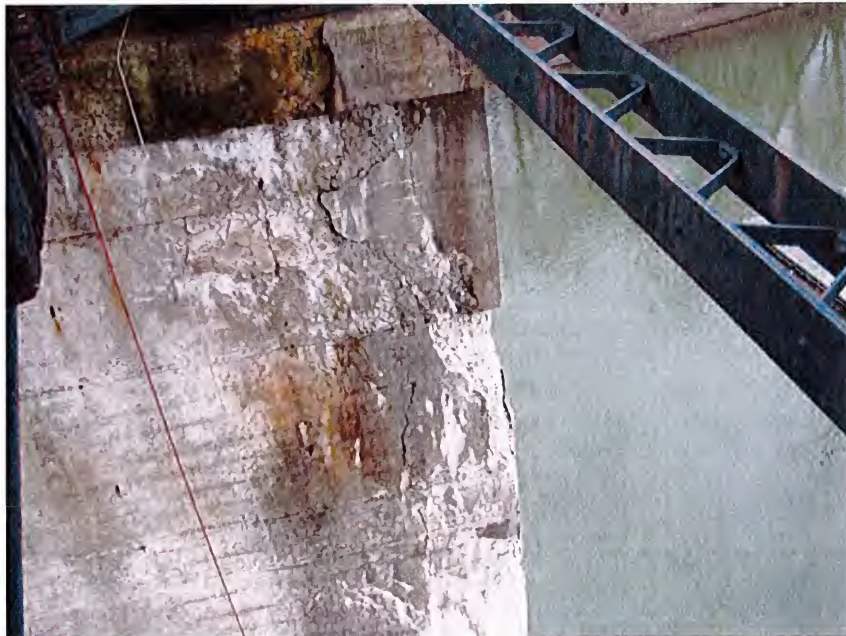
**Photo No. 3** Pier 25, south face, downstream

**Condition:** Cracking, delamination, and spalling in the upper pier shaft

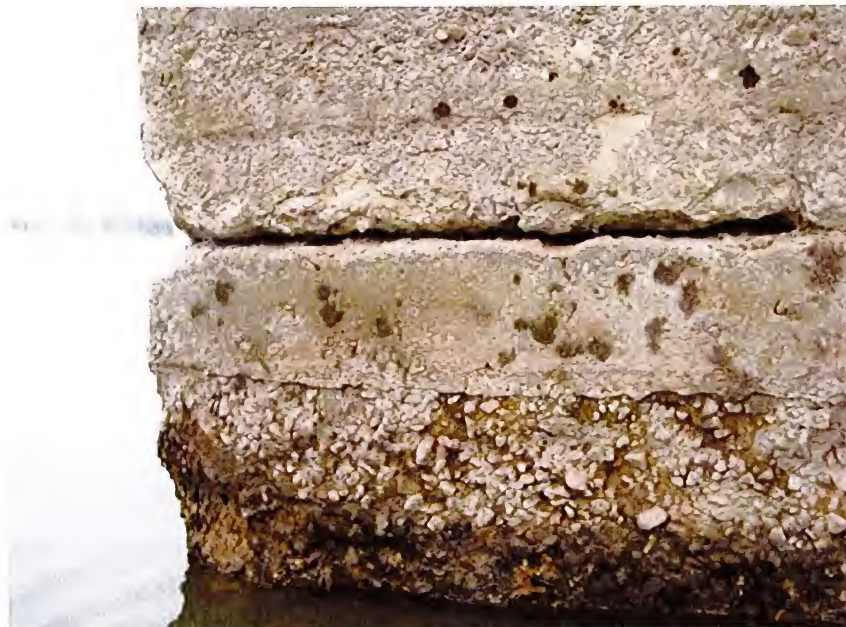
**Photo No. 4** Pier 26, downstream, south face

**Condition:** Severe scaling and open construction joint with spalling at the waterline

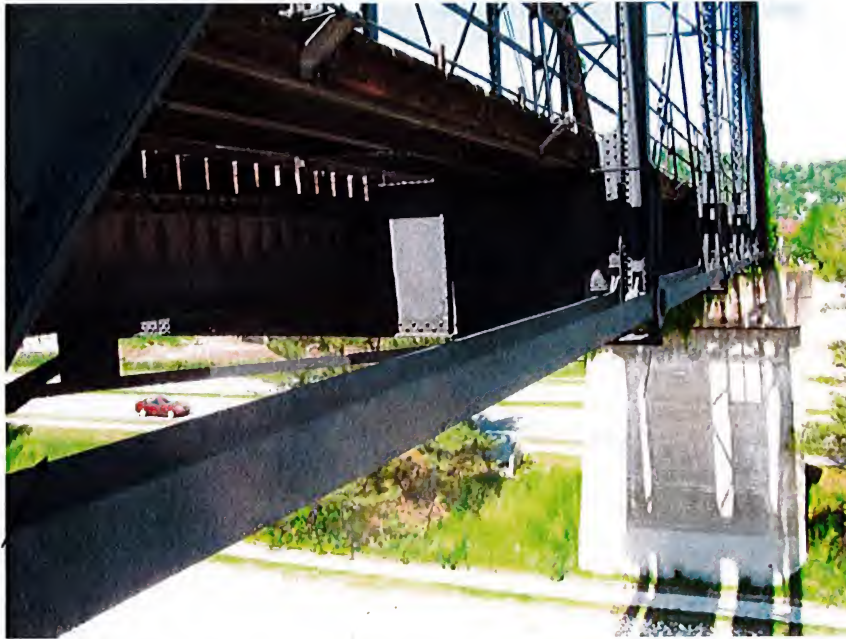
**Photo No. 5** Bottom chord, truss span, Pier 27 to Pier 28

**Condition:** Typical view of the truss span

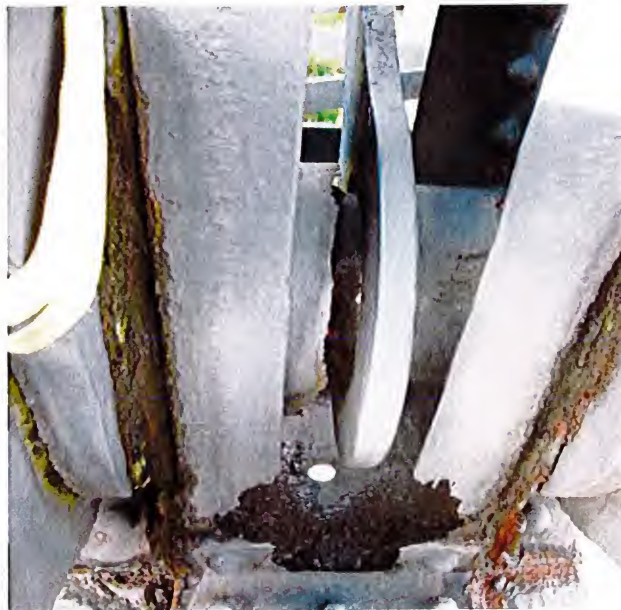
**Photo No. 6** L2, DS Truss Between P24 and P25

3. Significant rust packing and corrosion at all top and bottom truss chord connections was found (See Photos 5 to 8). The rust packing and corrosion has led to additional stress on the pins and section loss to the ends of the eye-bars of the truss members. The tightness of the rust packing and extent of the corrosion made it impossible to determine the remaining section. As part of the rehabilitation, we recommend blast cleaning the pin areas, re-inspecting the eyebars and ultrasonically test the pins. These areas also need to be repainted to prevent further deterioration. If the UT testing or the re-inspection reveals defects during construction, additional repairs may be required (Items 23 and 24 in the estimate).

**Condition:** 1" Rust pack with significant section loss to truss members

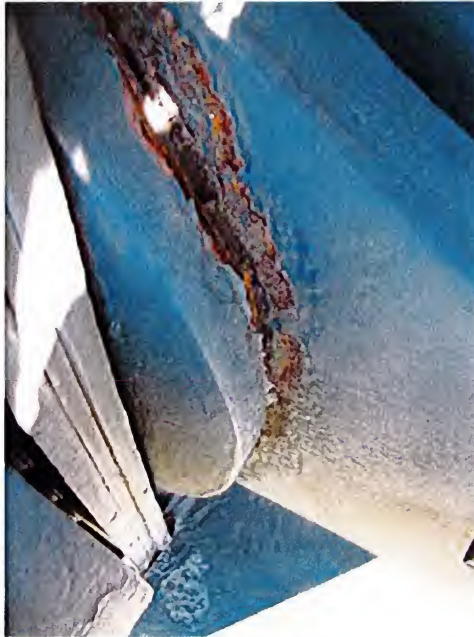
**Photo No. 7** Main River Truss, L4', Downstream Truss

**Condition:**  $\frac{1}{4}$ " section loss to the eyebars with  $\frac{1}{2}$ " rust pack

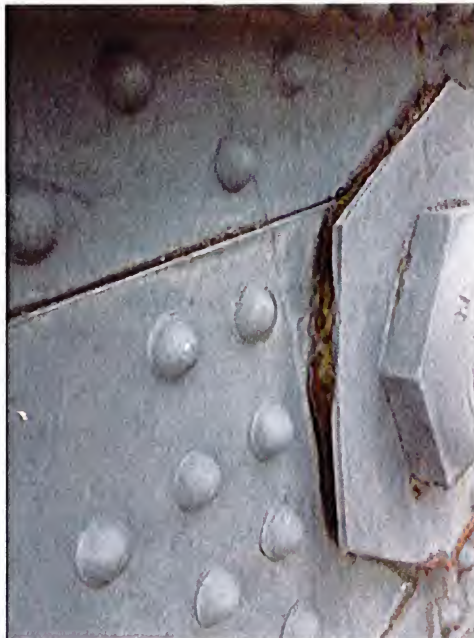
**Photo No. 8** Main River Truss, Top Chord at U4, DS Truss

**Condition:** Up to 1" rust pack with  $\frac{1}{4}$ " section loss to chord plate around the pin plate

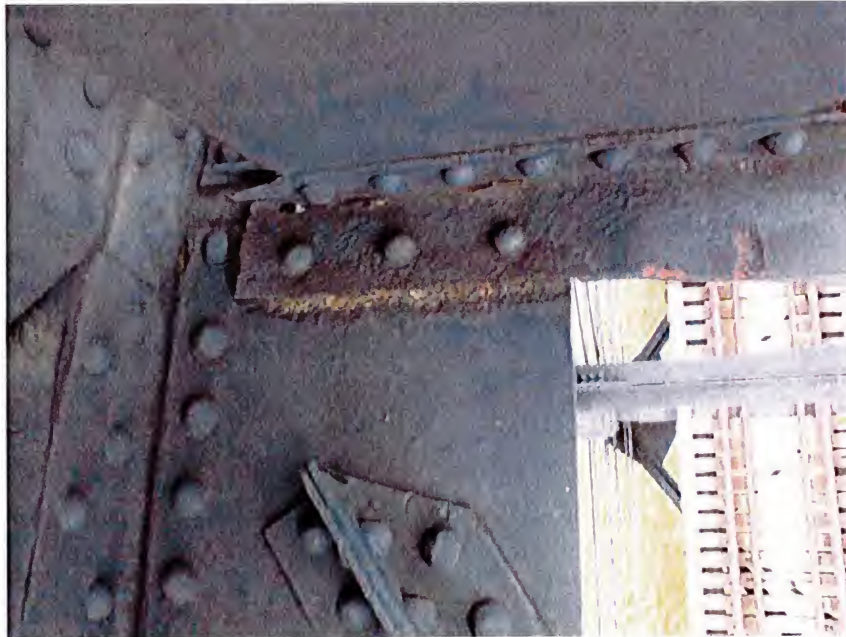
**Photo No. 9** Main River Truss, Top Chord at U2', DS Truss

4. The top lateral bracing for the main river truss and the flanking trusses have up to 50% section loss with small through holes at the connection to the top chord. It is estimated that several of these deteriorated areas will have to be reinforced as part of the rehabilitation of the bridge (See Photo 9 and repair item 25 in the attached estimate).

**Condition:** Up to 50% Section Loss to the end of the top lateral and the gusset plate

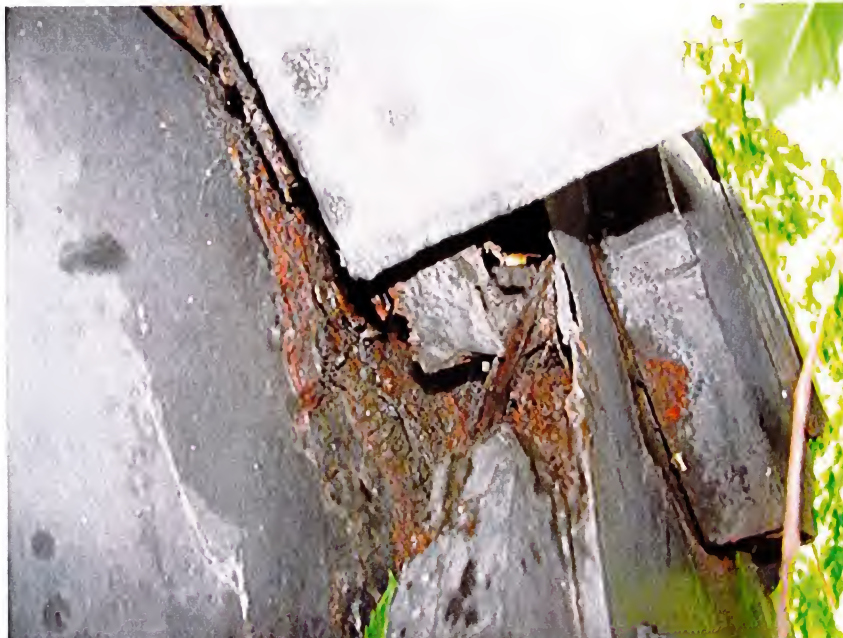
**Photo No. 10** Pier 24, US Truss at L0

5. The bottom chord and diagonal at L0, Pier 24 for the flanking truss have significant section loss and should be strengthened (See Photo 10 and Item 26 in the estimate).

**Condition:** Web of diagonal is 50% gone around pin and bottom eyebars have 1" of 1-3/8" remaining

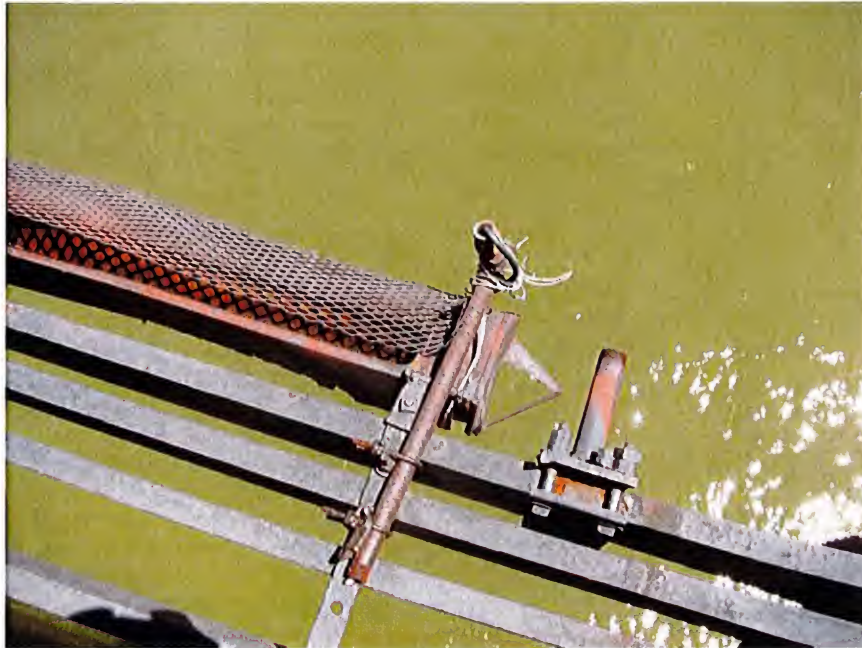
6. The navigational lights do not appear to be functional. The Coast Guard requires navigation lights over navigable rivers and clearance gauges on the main river piers (See Photos 11, 12 and Items 27 & 28 in the estimate).

**Photo No. 11** Main River truss at mid-span, US truss  
**Condition:** Missing navigation light

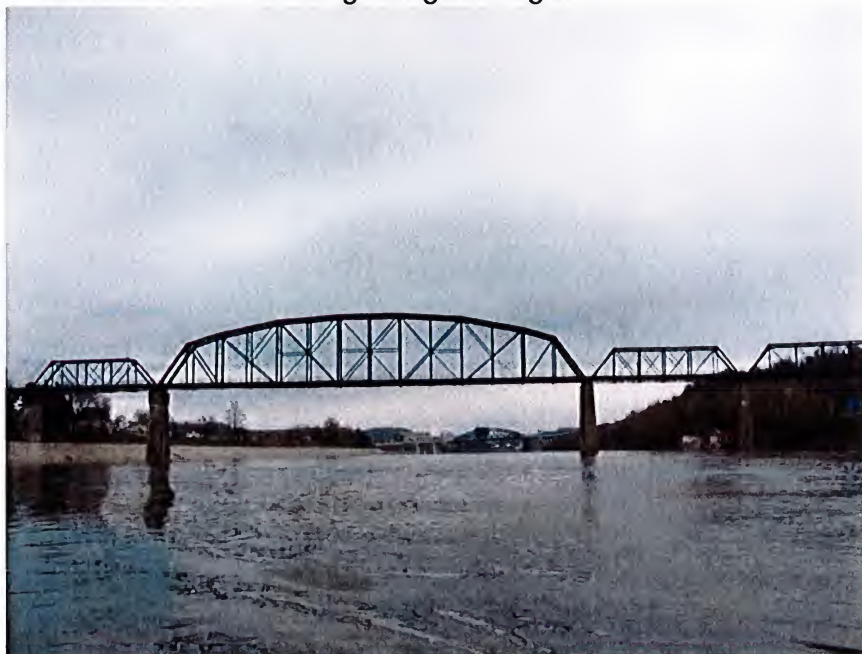
**Photo No. 12** Main River truss, DS truss  
**Condition:** Navigation Lights not working and no clearance gauges on piers

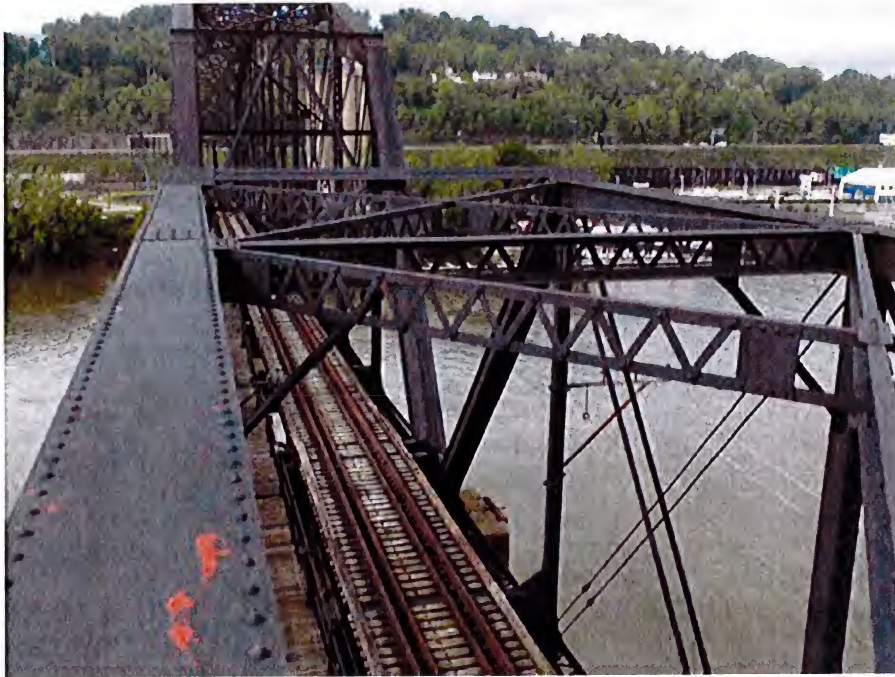
**Photo No. 13** Top Chord, upstream truss between P 27 and P 28

**Condition:** Typical condition of the paint with possible red lead primer beneath

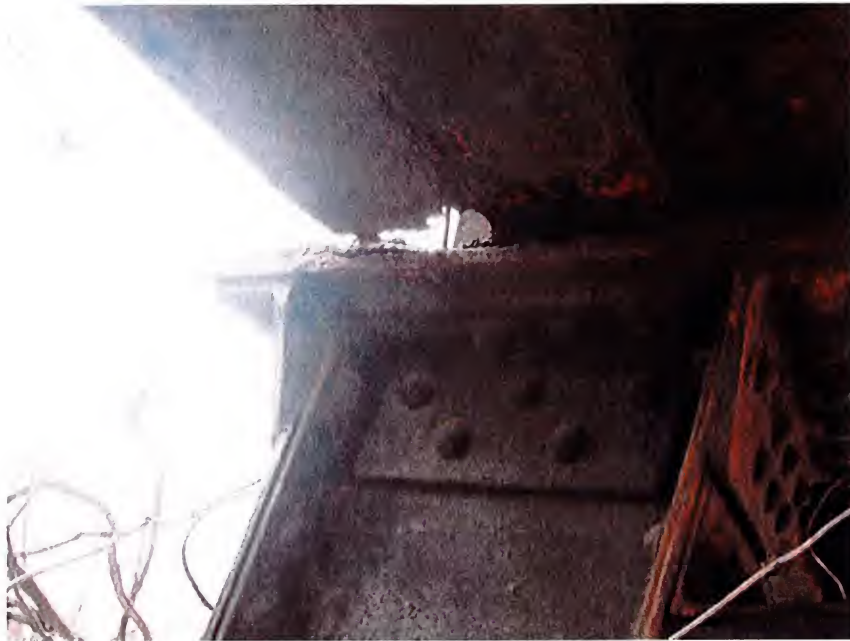
**Photo No. 1** Girder 2 at Bent B45

1. The bottom flange at several bents has 50% to 100% section loss at the girder bearing area. This condition is fairly typical to both girders in the steel spans on the Charleston side to various degrees. (See Photos 1 to 3)

**Condition:** 100% section loss to the bottom flange angles

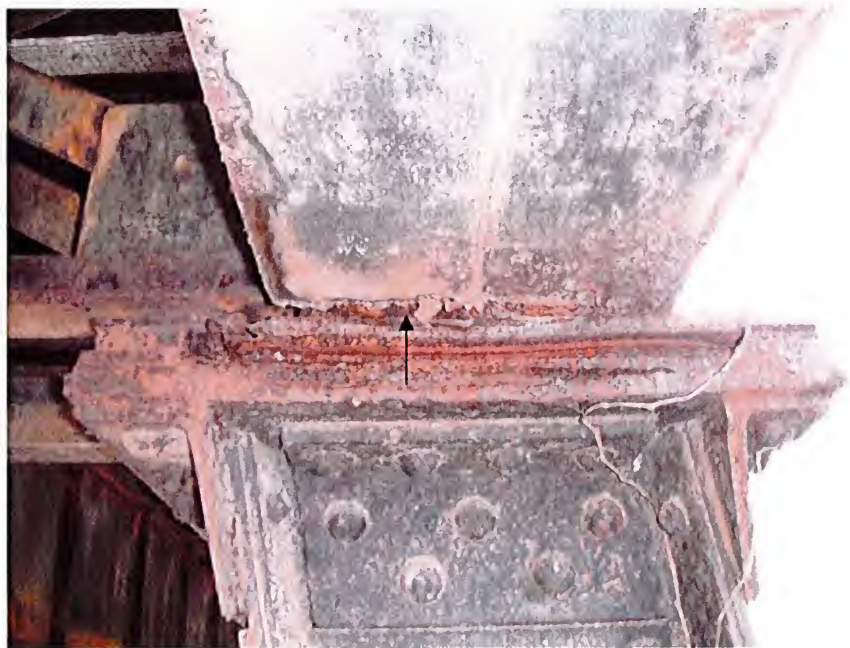
**Photo No. 2** Girder 2 at Bent A1

**Condition:** 90% section loss to bottom flange (See Arrow)

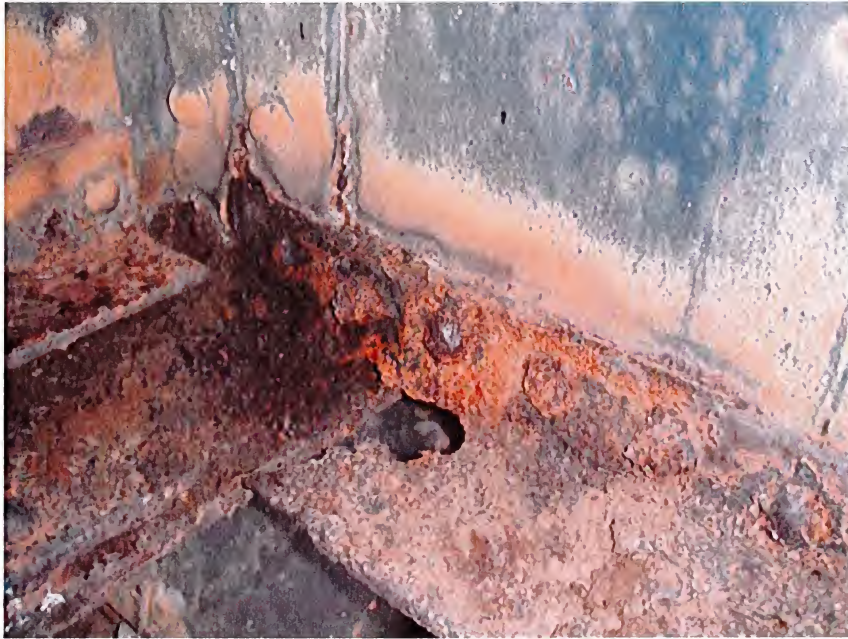
**Photo No. 3** Girder 2 at Bent A2

**Condition:** 100% section loss to the inside bottom flange angle

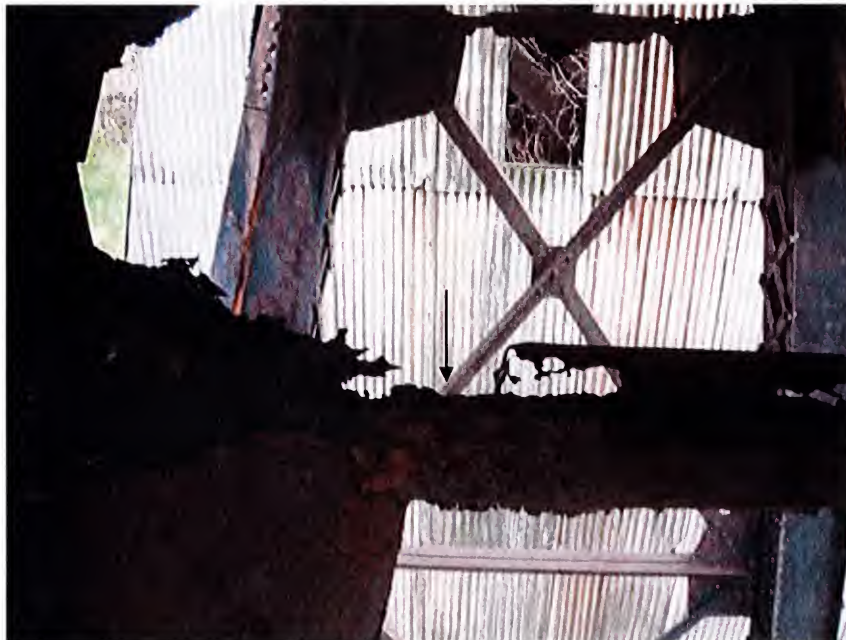
**Photo No. 4** Span A5 – A6, Sway Bracing Angles

2. There is a 10 ft. span between bent A5 and A6 over the sidewalk adjacent to 2<sup>nd</sup> Ave. This span has numerous defects and could potentially be replaced. The bottom flange is deteriorated to the point that the girder is bearing on its web. The top flange has an area that exhibits 100% section loss to the interior angle leg. The cross frame angles have up to 50% section loss. (See Photos 4 to 6)

**Condition:** Sway Bracing has up to 50% section loss

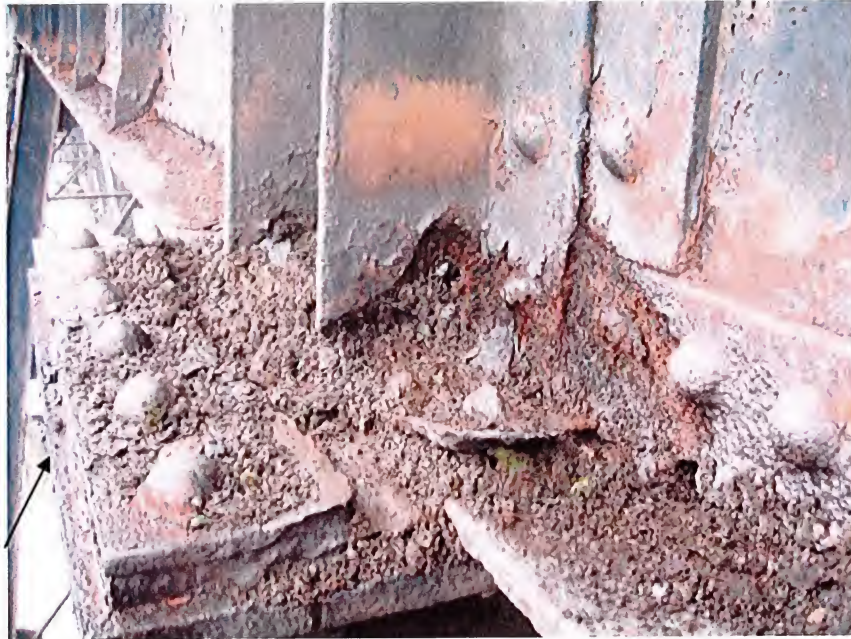
**Photo No. 5** Girder 1 Bearing area at Bent A5

**Condition:** Girder bearing on its web due to flange deterioration

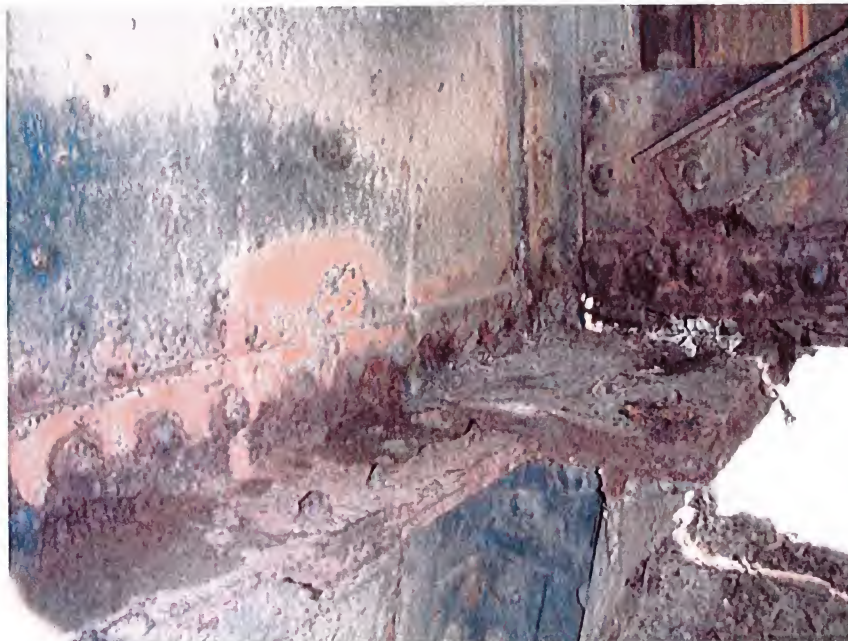
**Photo No. 6** Girder 1 at Bent A6

**Condition:** Bottom flange deteriorated at X-bracing support

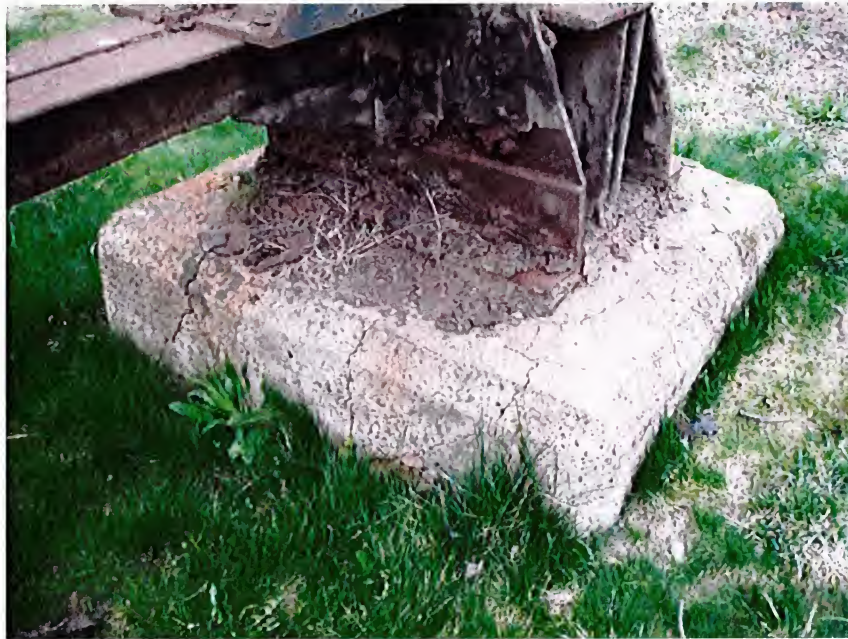
**Photo No. 7** Bent B15 (other locations similar)

3. Several of the concrete pedestals that support the steel tower bents are in need of repairs. They typically exhibit map cracking with up to 1/8" wide open cracks as well as spalls and crumbling concrete. (See Photos 7 to 8)

**Condition:** Map cracking with 1/8" wide open cracks

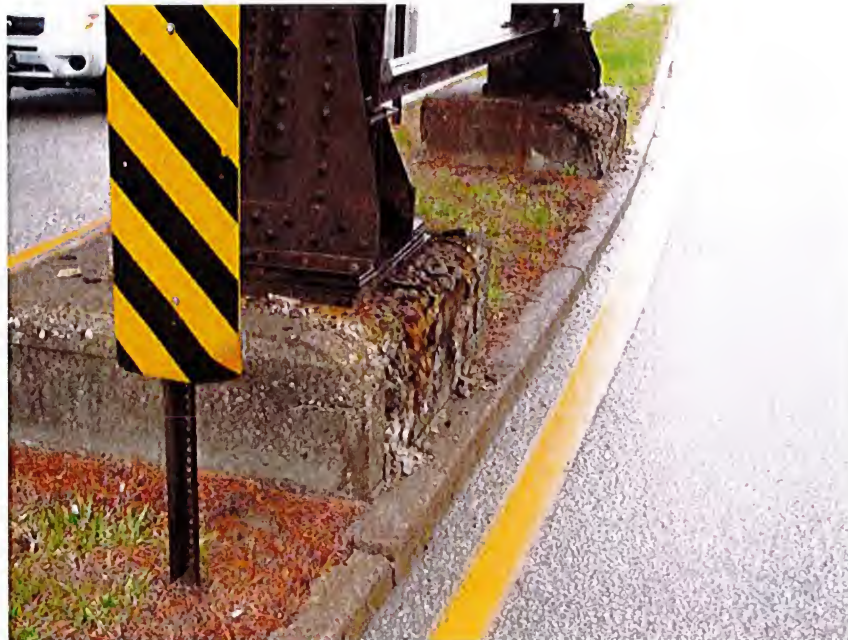
**Photo No. 8** Bent B30 (Median of Kanawha Blvd.)

**Condition:** Up to 3" deep spall to pedestal

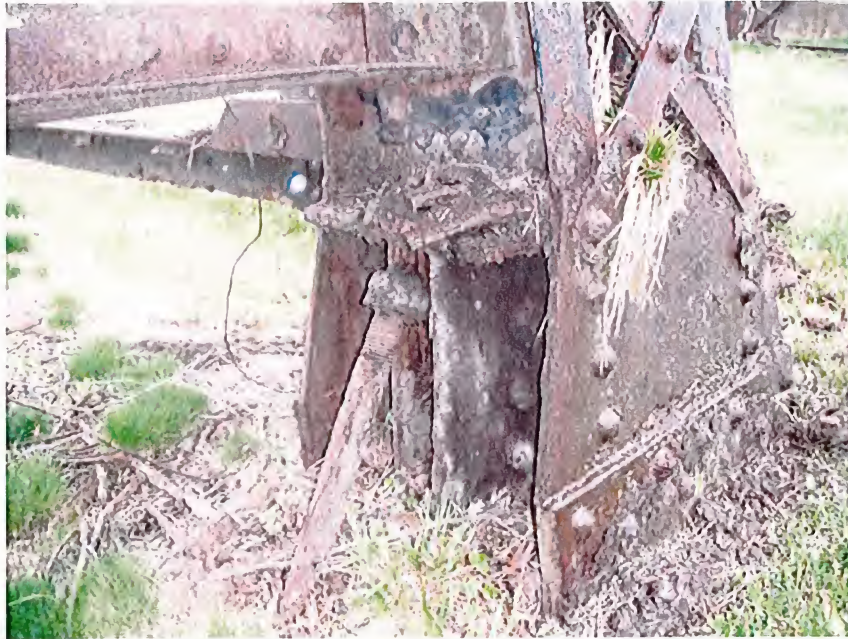
**Photo No. 9** Bent B8 (South Charleston Side)

4. During the inspection there were several bent column base connections and anchor bolts that were in poor condition. Anchor bolts were found to be missing, broken and loose. The bent column base connection was typically found to be full of debris and exhibits heavy surface rust and section loss. (See Photos 9 to 10)

**Condition:** Broken anchor bolt

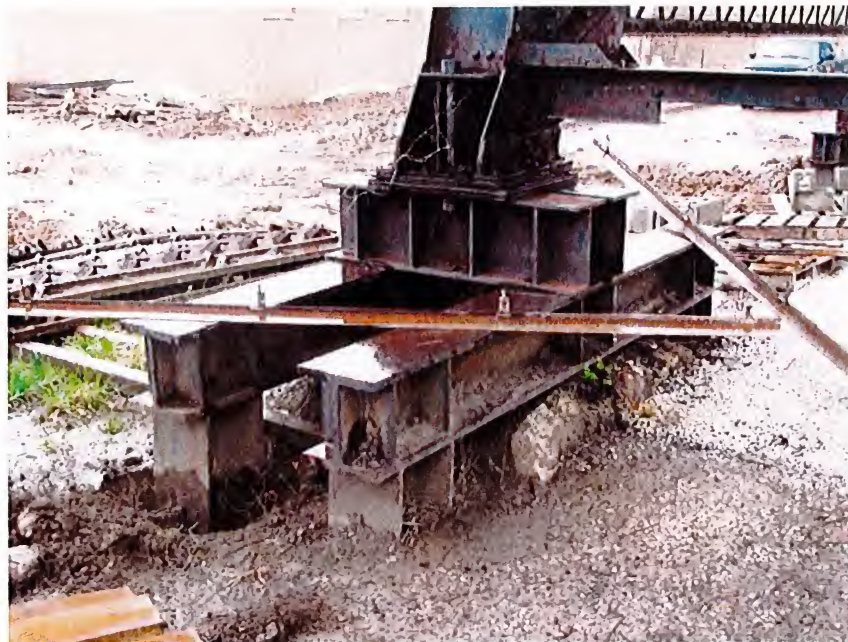
**Photo No. 10** Temporary bent support at Bent B33

**Condition:** Repair bent column base connection, pedestal and anchor bolts

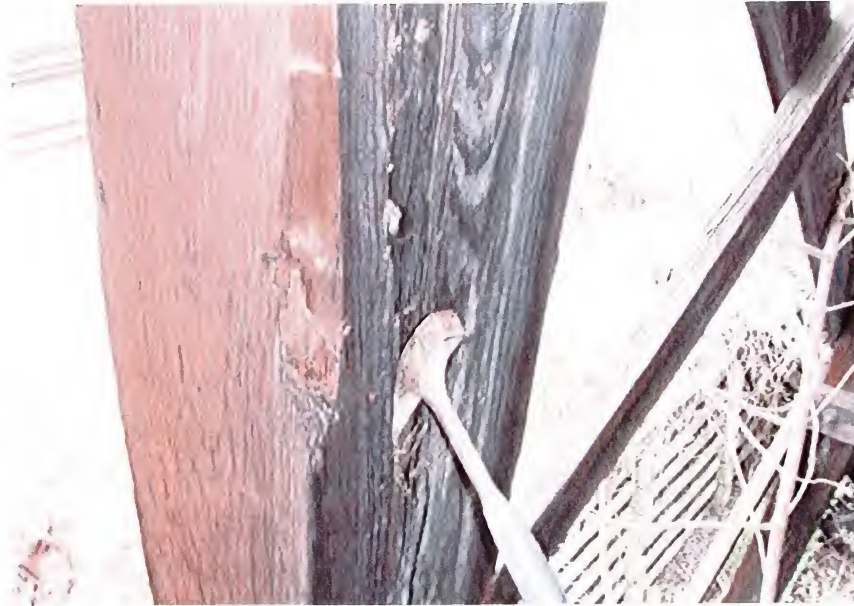
**Photo No. 1** Timber Bent T73

**Condition:** Vertical Split in Post affecting 15% of pile area.

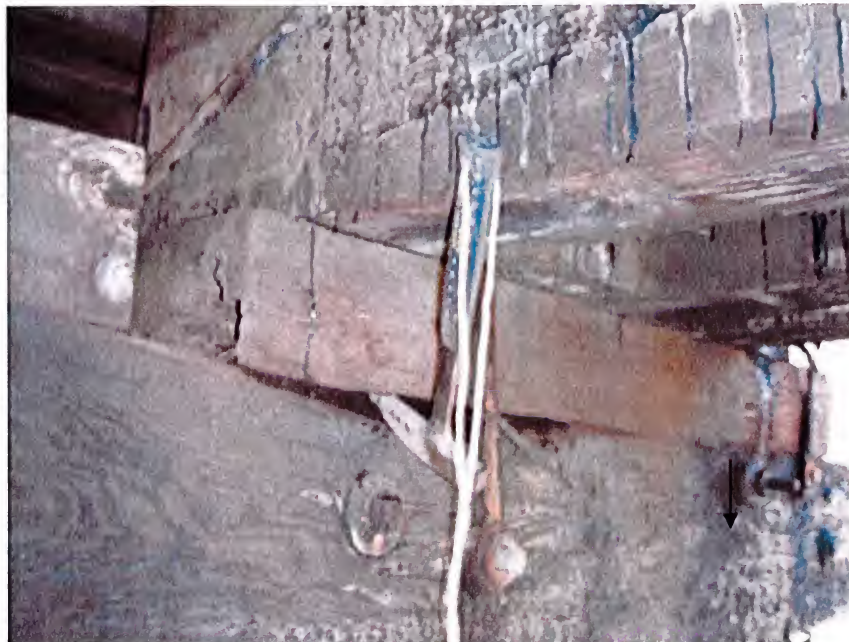
**Photo No. 2** Timber Bent T72

4. The bearing shims on top of the bent caps are crushed or rotten in multiple locations (See Photos 2,3, & 6). These shims should be replaced and they are quantified in item #16 and item #50 on the cost estimate.

**Condition:** Shim block is 50% rotted, replace

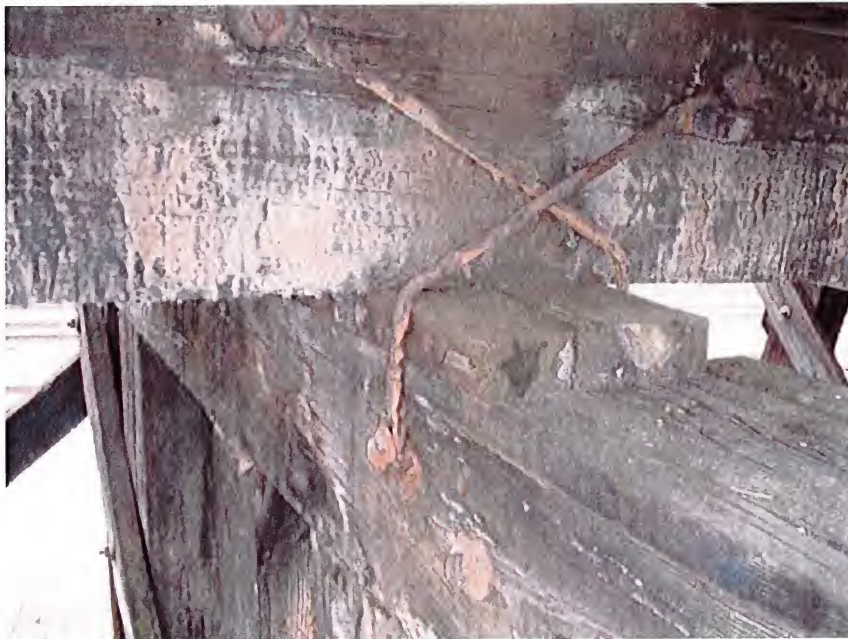
**Photo No. 3** Timber Bent T72

**Condition:** Timber Shim is split and brooming.

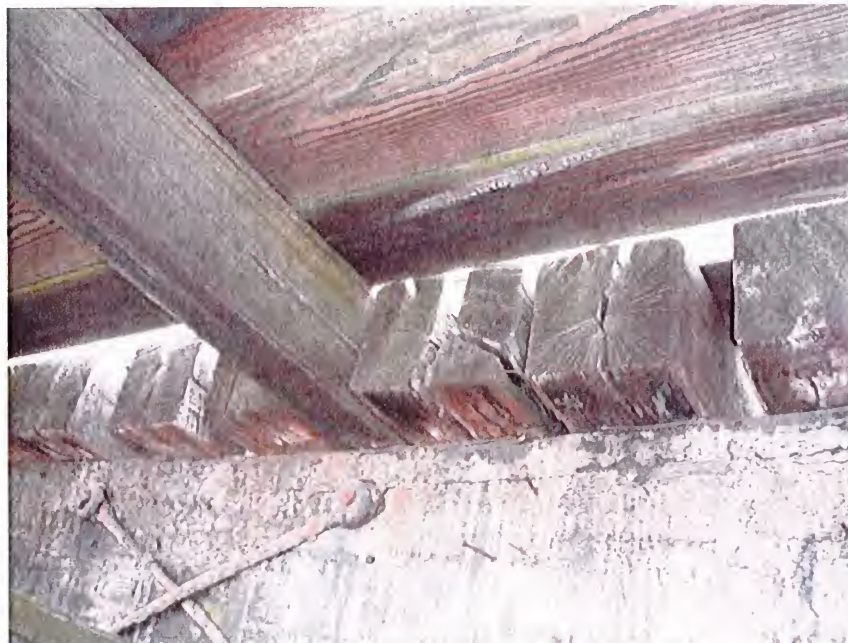
**Photo No. 4** Deck ties along stringer 1.

**Condition:** Deck ties split at end, typical 50% of ties

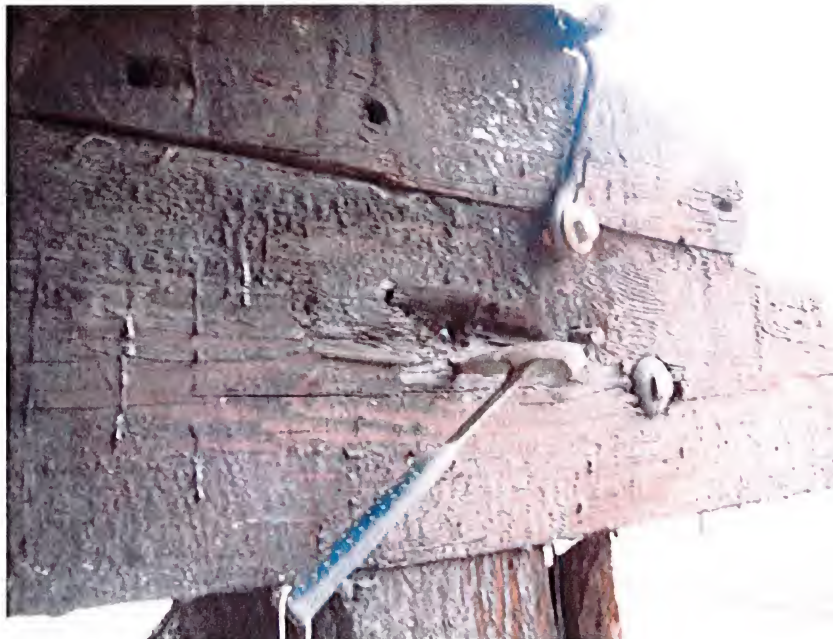
**Photo No. 5** Timber Bent T80

1. Timber bent caps at several locations show different degrees of decay. This condition is evident on both sides of the river (See Photo 5). This repair is quantified in item #15 and item #49 on the cost estimate.

**Condition:** 35% of cap is decayed

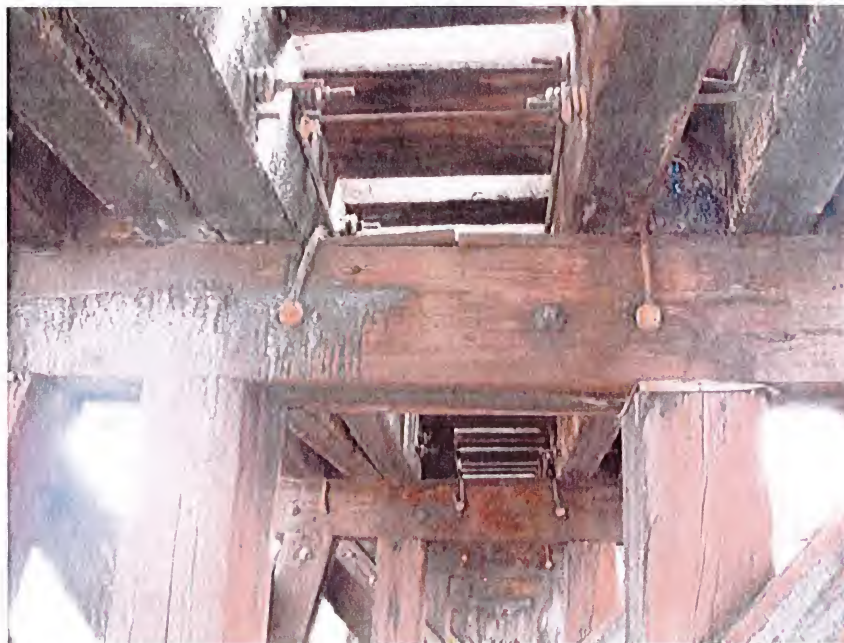
**Photo No. 6** Timber Bent T81

**Condition:** Bearing shims are crushed

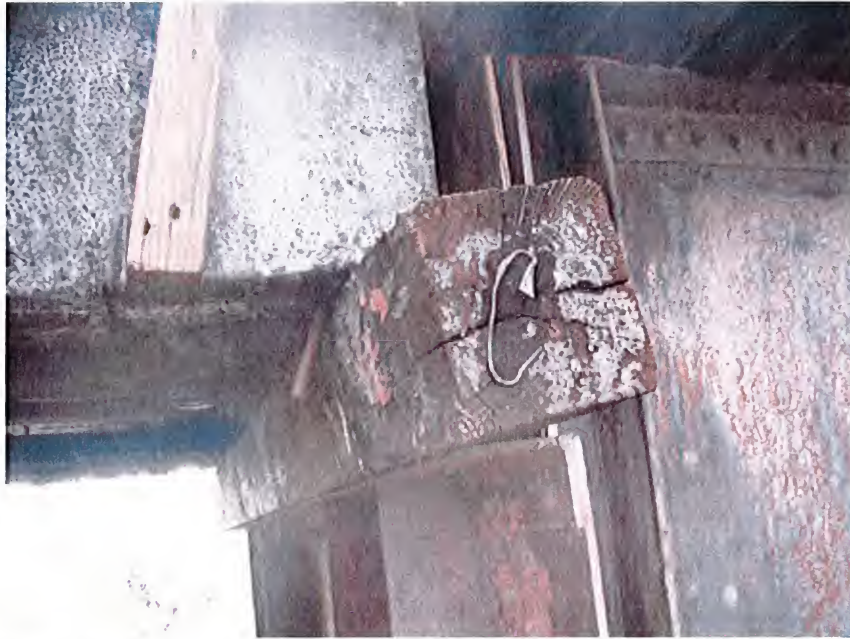
**Photo No. 7** Timber Bent T84

**Condition:** Bent Cap is tilting, needs reset

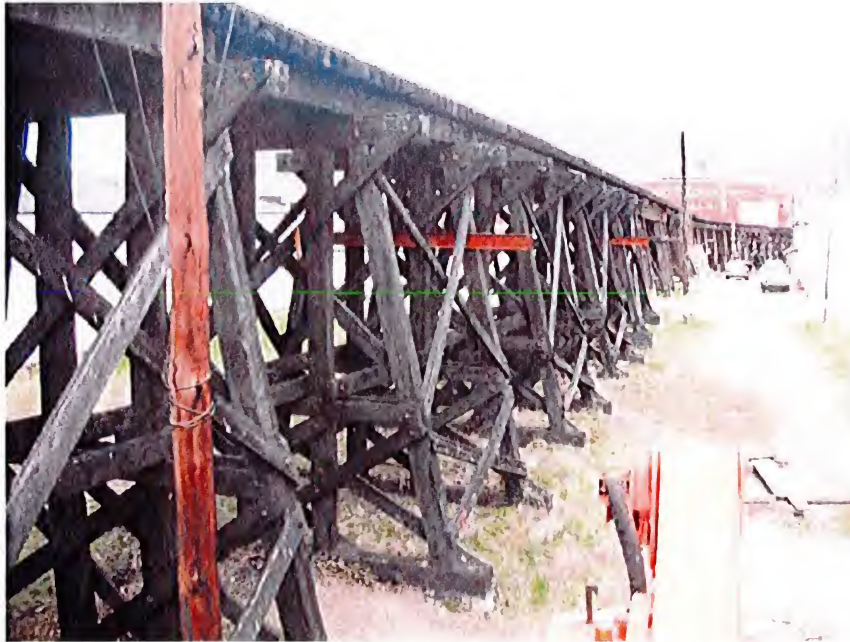
**Photo No. 8** General View T112 – T121

6. On the Charleston side of the river, several timber bents and stringers were damaged due to fire (See Photo 8). This area should be coated with the possibility of some members that are excessively damaged to be replaced. This cost is included in item #45 on the cost estimate.

**Condition:** Fire Damage

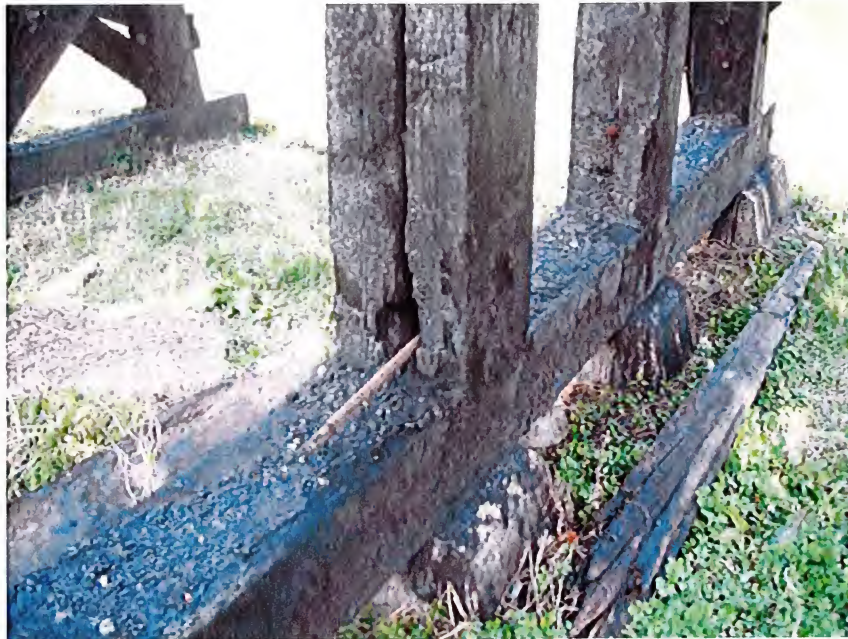
**Photo No. 9** Timber Bent T120

**Condition:** 4" dia. Hole and full height split in post

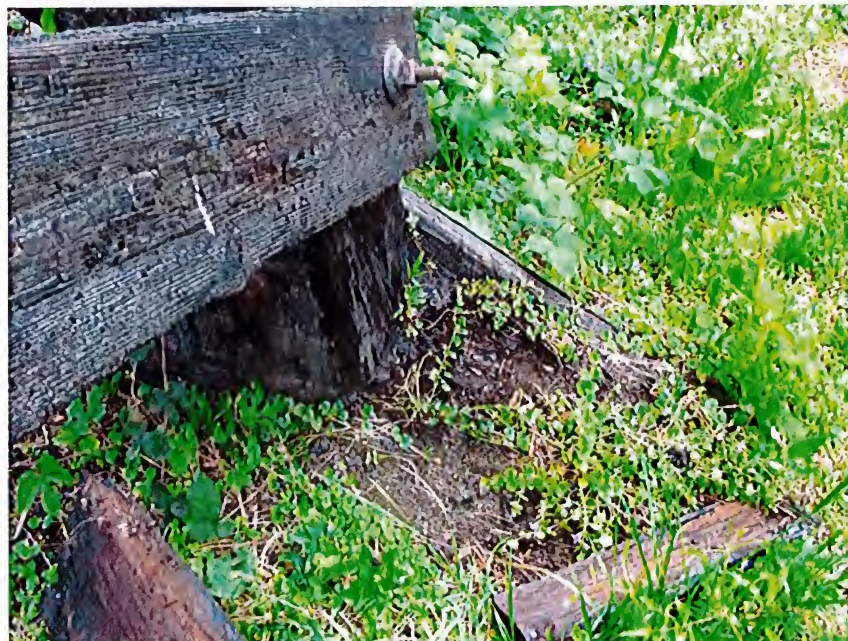
**Photo No. 10** Timber Bent T114

3. The timber bent sills in select locations show large amounts of rot (See Photos 10 and 12). These sills need to be replaced and they are quantified in item #12 and item # 47 on the cost estimate.

**Condition:** Sill completely rotted, replace

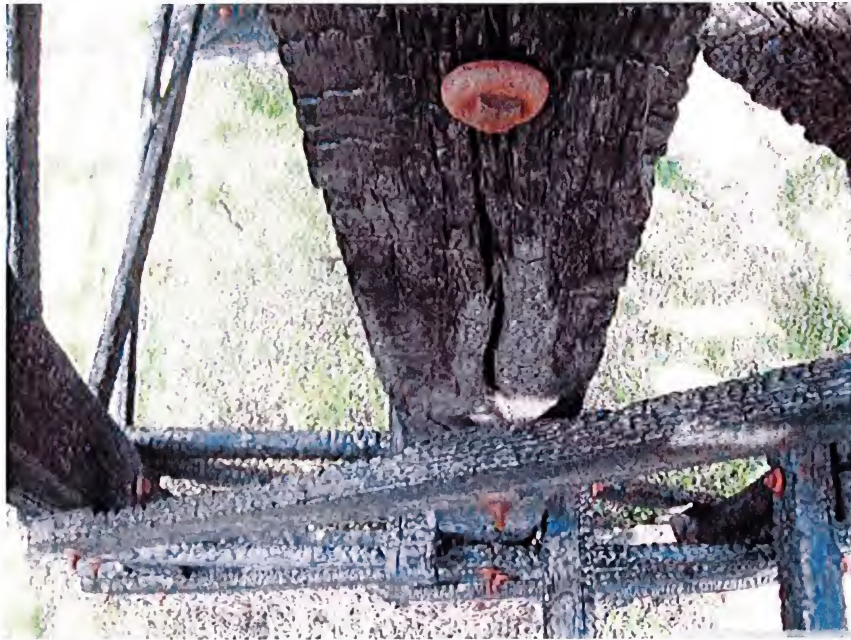
**Photo No. 11** Timber Bent T116

5. Several timber posts are excessively split and their load carrying capacity is reduced (See Photo 11). These posts should be replaced and are quantified in item #51 on the cost estimate.

**Condition:** Post Split, full height

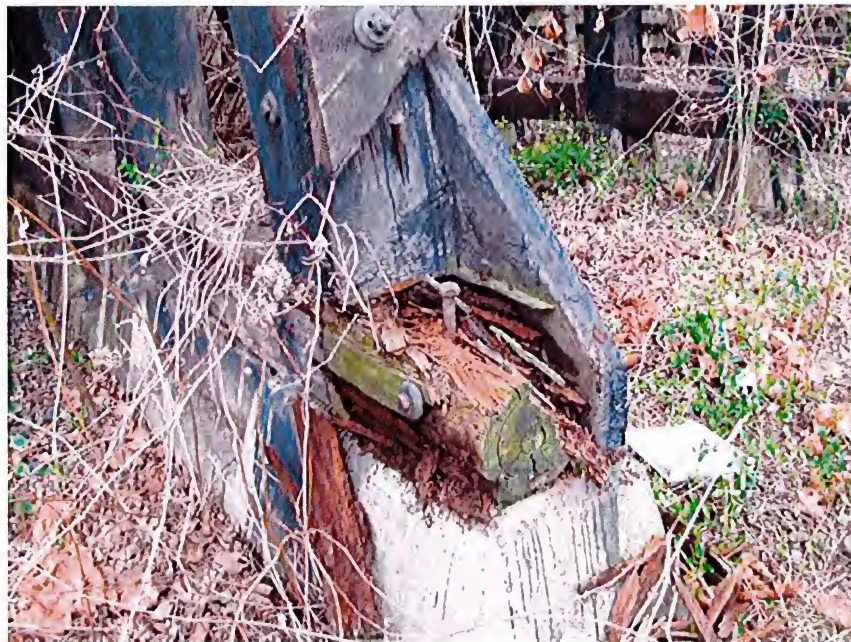
**Photo No. 12** Timber Bent T35

**Condition:** End of Sill rotting, undermining support post

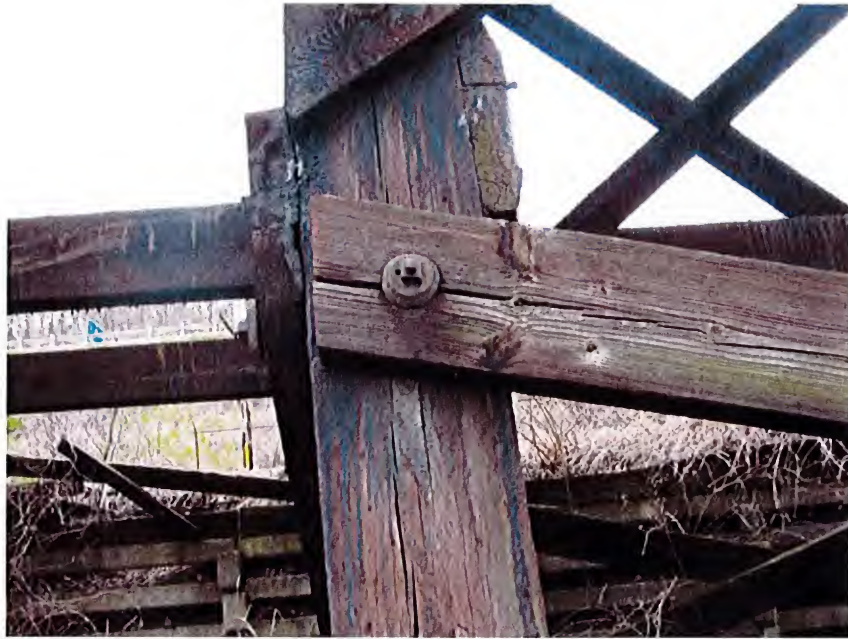
2. Several of the longitudinal and transverse bracings have fallen or are split and unable to transfer load (See Photo 13). These braces need to be replaced and is quantified in items #11, #13, #46, and #48 on the cost estimate.

**Photo No. 13** Timber Tend T43  
**Condition:** Typical Split in Diagonal Bracing

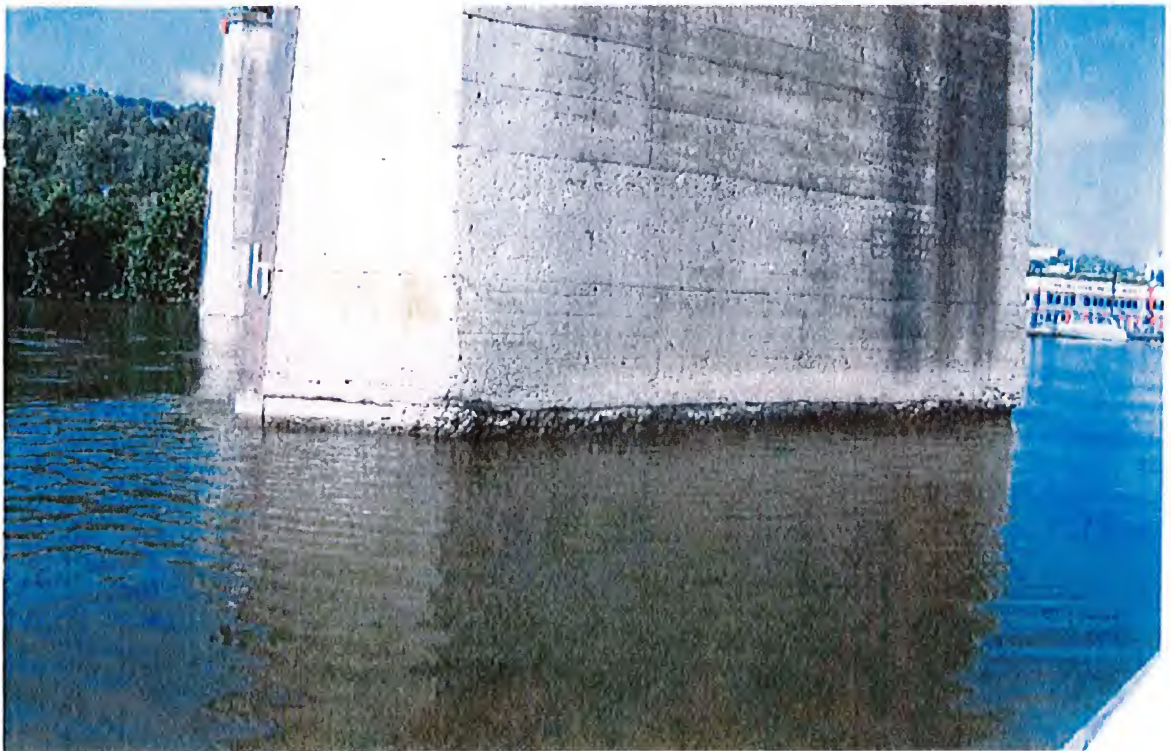
**Figure 4. Severe concrete scaling at the waterline of Pier 3 (looking downstream)**
